A Unique Thermal Problem Found in Certain Double-Glazed Windows

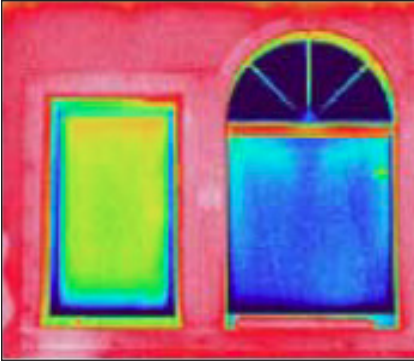
The relative thermal performance of three windows: single-glazed (top), double-glazed with nitrogen gas (right) and double glazed with argon-fill (left), is readily apparent in this thermogram taken from inside during the heating season.

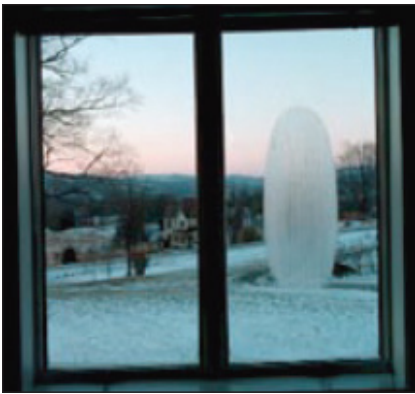
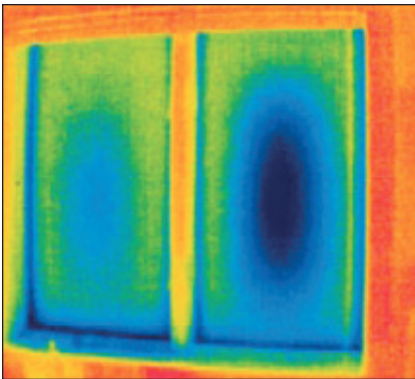
Windows exhibiting this anomalous pattern are argon-filled units, and generally not large ones. Over time the argon gas escapes from the window, but it is not easily re-

Condensation formed first on the right window which was exhibiting a more advanced stage of argon gas loss than the left window. The thermograph shows that in fact both windows have the same argon loss.

placed by air, leaving the internal space at a negative pressure. The panes of glass are thus pushed together resulting in increased heat transfer and, when conditions are right, condensation in the center of the window.

The causes for the argon loss are interesting. Some is certainly lost due to inadequate design or construction, especially of the spacer in the corners. Sealants too have long been recognized as a weak point. Argon molecules are smaller than most of the gases which compose air, it can travel through many sealants which were previously used to contain other gases. Some sealants obviously allow argon to pass through them, but not allow air to replace the displaced argon.

Window manufacturers have been working on several fronts to minimize the problem of argon depletion. Changes have been made to the way units are filled to assure they are actually full at the time of manufacturing. Sealants have also been improved, and in some cases, two types of sealants are used rather than a single one; designs also now incorporate longer sealant pathways so that the gas must go further if it is to escape. Spacers and sealants are more carefully installed, especially at the corners where signifi-

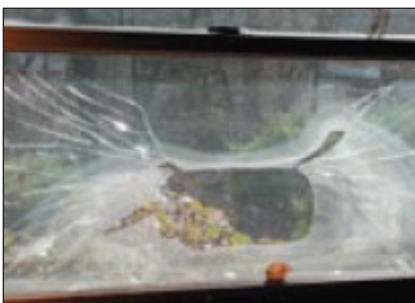
Imploded window with gaping oval hole in the inner glass.

All of the above factors probably work together with the result being that over time the unit loses argon and pressure. When conditions are right, especially during colder weather, thermal stresses may become so great that the window unit may actually implode. Reports indicate that smaller units, with a short dimension of 10”–20”, are particularly vulnerable where pressure induced deflection exceeds the material failure point.²

Interestingly, several of the windows in the home of the brother of one of the authors recently imploded. Two small windows (12” x 24”) shattered leaving a gaping oval hole in the inner glass. Both units were seven years old; many of the other IG units in the house have exhibited the anomalous condensation patterns, but no more have imploded. It is probable that the larger size windows allow enough deflection such that they do not fail as often.
