A Convincing Lesson on the Power of Convection Cooling

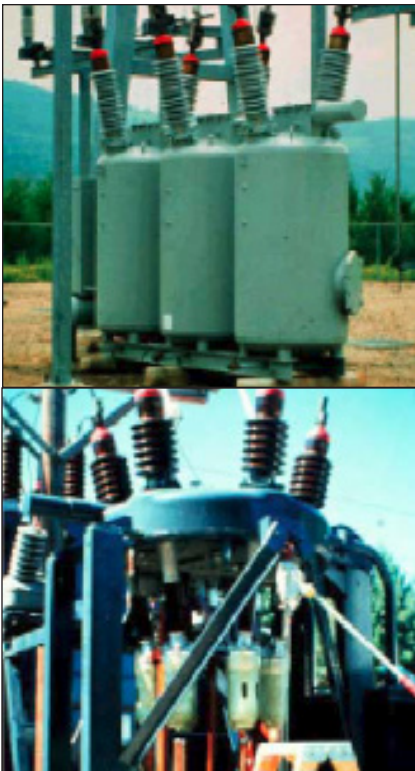
Figure 1. A set of 3-phase oil-filled circuit breakers (OCBs) seen from the outside (above) and another set (below) from the inside, with the oil drained, showing part of the bushing structure and contacts.

While inspecting a set of Oil filled Circuit Breakers (OCBs) in the switch yard, as seen in Figure 1 (left) for the powerplant, several students found a “hot spot” on the load side of the B-phase bushing; it clearly showed a temperature difference (ΔT) of 13°F over the normal phase. With loads running at maximum, as they were, this temperature rise was deemed a concern but not a high enough priority to warrant immediate concern. The students also noted an almost imperceptible anomaly on the line side B-phase which was indicated by a ΔT of only 4°F. Both anomalies can be seen in Figure 2 (left). Both appeared to be related to a threaded connection in the top of the bushing assembly.

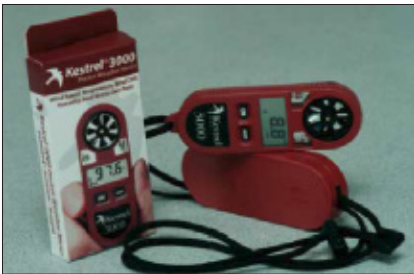
Figure 6. The Kestrel 3000 is an affordable solution to gathering accurate local climatic data essential to diagnosing IR problems.

We have used, and can recommend, the Kestrel Model 3000 as being rugged and reliable; cost is approximately \$150, see Figure 6 (left). A new model, the Kestrel 5000, costs about \$250 and can be left unattended to automatically make, store and display graphically a series of measurements over time. If you are unable to find these products locally, they are available on our website at www.snellinfrared.com.
