Do Sweat the Small Stuff – The Benefit of Inspecting “Small” Equipment with Infrared Thermography

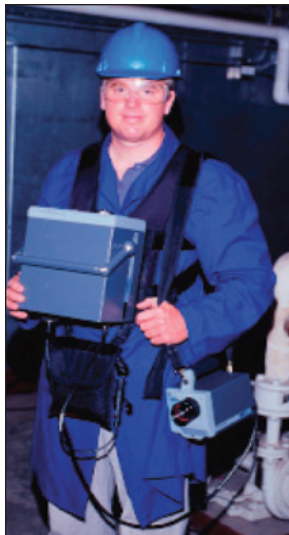
As an instructor of IR, I often have students in level one courses who complain about the size and weight of their cameras. That all ceases after I show photos of older equipment, Figure 1 (left), such as this Inframetrics 740 rig from back in the early 1980’s. Believe it or not, this was once considered “man-portable”.

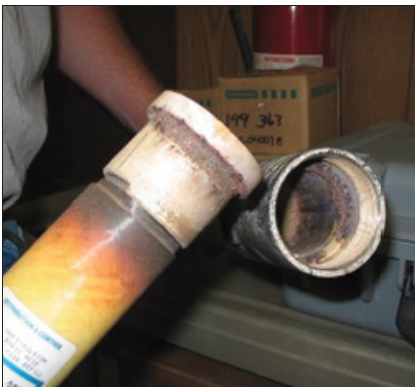
One common misconception is that the resistance within the connection point has to be very high in order to cause heating.

Most anyone with knowledge of thermography as applicable to electrical apparatus inspections understands how we find anomalies. Increased contact resistance in an electrical connection causes heating that increases as the square of the applied current. For this reason, NFPA-70B (*Recommended Practice for Electrical Equipment Maintenance*) suggests a minimum of 40% load on a circuit at the time of inspection with IR for optimum results. One common misconception is that the resistance within the connection point has to be very high in order to cause heating. This is untrue. In Figure 3 (top left), the electrical resistance between the failed component and the new replacement component was 2.2 *micro*-ohms. Not exactly what we would normally consider “high”, but significant nonetheless.
