Successful Warm-Weather Infrared Inspections

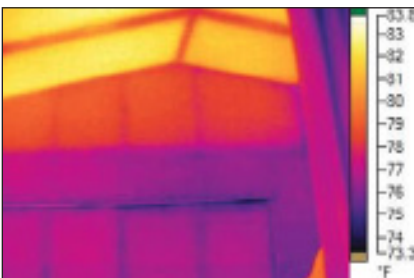
Image 7. The thermal pattern of apparent missing insulation between the roof joints is clearly seen at the top.

This infrared image (see Image 7) was taken last summer in northern Vermont from inside a residential home. The thermal pattern of apparent missing insulation between the roof joists is clearly seen at top with the warmer bays and relatively cooler framing members. The wall, however, showed a somewhat more confusing pattern that was initially difficult to interpret.

The top quarter of the wall appeared to be warmer than the bottom part, but both were still cooler than the ceiling. Was there missing insulation here and we were seeing the level? Varying wall thicknesses? Different angle of the sun? Possibly, but nothing was discernable to any degree of confidence...at least from the interior!

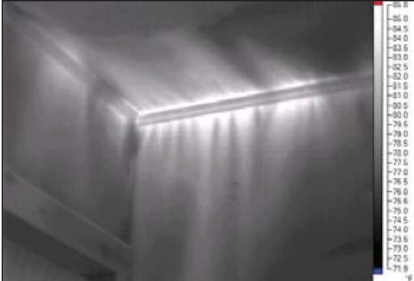
Image 9. The use of a blower door helps make summer inspections possible.

leakage patterns that are not typically seen with the natural stack effect. It is also beneficial when you encounter a situation where the inside-to-outside temperature difference is marginal. The blower door helps drive warm or cool air movement patterns across the envelope, making “swing season” and summer inspections both possible and practical.

Typically depressurizing to about 20 Pa is sufficient and provides enough of a draw to move air so its effects can be seen thermally. It can take up to a few minutes (sometimes more) for the pattern to door is running watch for sources of warm air infiltration. This approach certainly works for air leakage and can possibly help reveal insulation patterns that are not seen naturally.
