Testing Building Envelope Systems Using Infrared Thermography

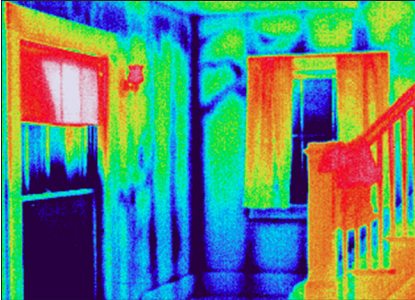
Image 2. When conditions are right, it is possible to locate missing or damaged insulation, such as this poorly installed injected foam in a residential building.

It is essential to know the type of insulation in the building and construction details, including how the insulation was installed. Insulation may be in place but not performing; often a destructive evaluation is warranted to establish baseline conditions or understand the exact construction detail. Each type of insulation has a characteristic thermal pattern. Image 2 (left) shows a classic pattern associated with injected foam

insulation in a wood-framed wall. This type of insulation, a soft foam, is susceptible to shrinkage and cracking when poorly installed.

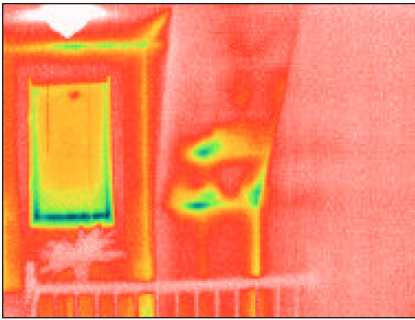
Image 3: The improperly installed fiberglass yields an irregular thermal pattern. The resulting cold spots commonly host wall stains or mold growth.

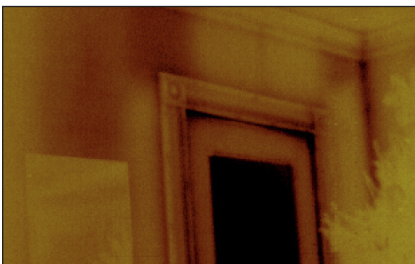
Image 4: Properly installed cellulose is an excellent insulation. Unfortunately, it is often poorly installed with missed areas and settling the most common quality problems.

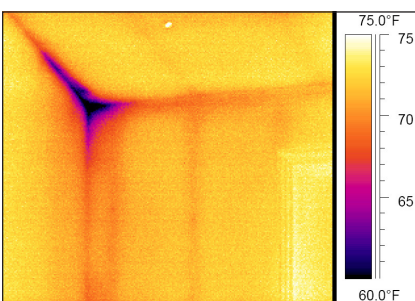
Image 5: Many types of insulation are susceptible to air infiltration. The fiberglass shown here does not stop air flow through the wall section.

Most types of insulation are not effective at reducing air movement through the thermal perimeter. Good construction practice includes interior air sealing; if this is not in place effectively, air can move through the interior and exterior surfaces and through the insulation. Unfortunately, fiberglass is particularly susceptible to the this problem. Thus, while the insulation may be present, it does not perform as expected when the building is under a pressure gradient. Image 6 (next page) shows the impact of warm air leaking out of this commercial building. This will typically go unnoticed until the fuel bill is paid.

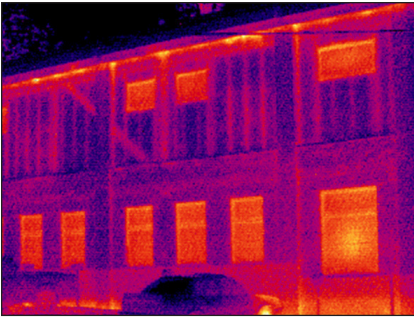
Image 6: All the framing and insulation is clearly visible in this commercial building. Normal pressure differences on the top floor result in air leaking past the envelope through various pathways.

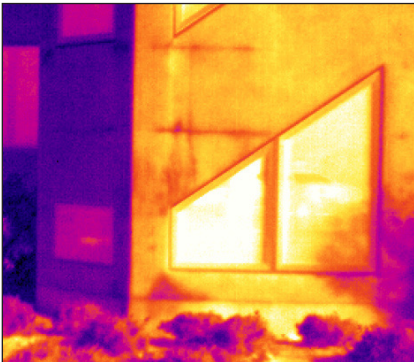
Image 7: EIFS construction is particularly susceptible to water intrusion resulting in both mold growth and wood rot problems.

The growing popularity of buildings using Exterior Insulation and Finish Systems (EIFS) has been accompanied by numerous cases of moisture-related structural damage. Although often attributed to leaking windows, water typically intrudes where sealing or flashing systems were inadequate or have begun to fail. Moisture is then trapped under the relatively impervious foam. In warm climates the decay of structural wooden elements, which can occur very rapidly, is a major problem. Mold growth also often accompanies the moisture resulting in health concerns.

Thermography is an invaluable tool to locate moisture in EIFS systems. Inspections are best conducted in the early evening from the outside after a sunny day with little or no wind. It may also be possible to locate moisture from inside during cooling or heating conditions. The expanded foam insulation boards tend to become more absorbent to water over time.

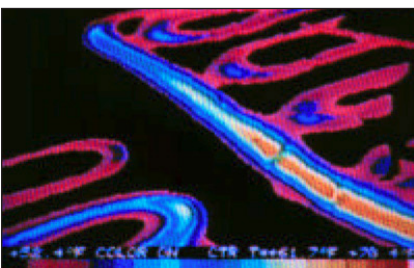
Image 8: Hydronic heating coils embedded in a concrete floor show up in this thermal image.

Heating coils are being used more and more either to keep outside walkways or entrance ramps snow free or to provide heat to areas and rooms via hot water or electric cables. Thermography provides a quick way to verify location and performance of these subsurface devices. Typically the thermal pattern shows up very clearly even when the heat source is embedded in several inches of concrete. Similarly, water pipes in wall sections can usually be located quite readily.

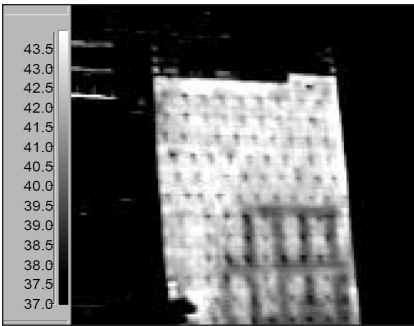
Image 9: This block wall is not uniformly grouted as was specified, leading to severe structural problems.
Image courtesy Phil McMullen.

No area of application is more important these days, particularly in commercial buildings, than the verification of construction details and performance. Thermography is being used with great success to verify bond beams and placement of reinforcing in concrete masonry unit (CMU) walls as well as structural elements of pre-cast, tip-up walls. How? The solid portions of the wall change temperature more slowly than the rest. The inspection can be conducted anytime the wall is in a thermally transient condition – typically in the early evening as it cools down. Because the inspection is conducted during construction, deficiencies can be corrected prior to occupation with relatively minor inconvenience. Verification of placement of insulation in masonry unit walls is also more important than in the past due to high energy costs and health concern regarding mold growth in cold wall cavities.

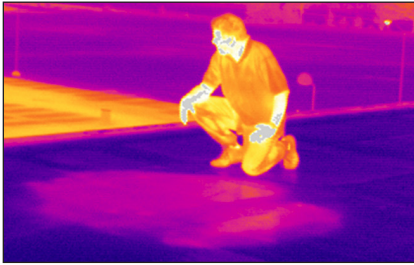
Image 10: The wet insulation in the roof system shows up clearly due to its greater thermal capacitance.

The inspection of flat roofs, especially built-up roofs (BUR) has been proven for a number of years. The technique allows for the detection of moisture trapped in a roof system; over time this moisture leads to the pre-mature degradation of the roof. The moisture appears warmer at night after a sunny day due to its greater thermal capacitance. The roof surface must be dry and the technique works best on roofs with absor-

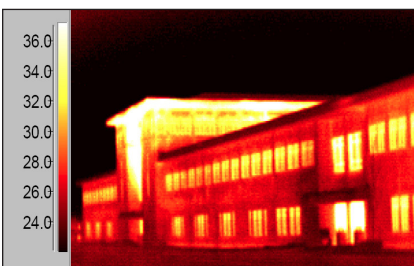
Image 11: During the commissioning of this building thermography revealed an extreme problem involving exfiltration through the soffit. *Courtesy Phil McMullen.*
