Best Practices for using Infrared Thermography for Condition Monitoring of Utility Substation Assets

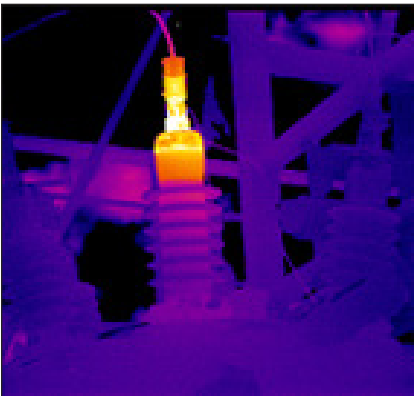
Figure 2. Heating on this oil-filled circuit breaker bushing is caused by high-resistance in the connection between the cap and the bushing rod.

- **Bushings:** Both high- and low-side bushings can be profitably inspected with thermography. When under load, anomalous conditions can often be found easily on the line-side connections. Internal connections, both in the bushing head (Fig. 2) and in
